I Stainless steel swimming pools I

Metal Engineering

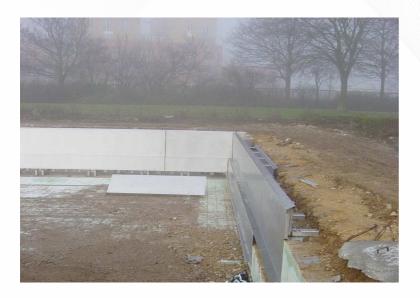
The stainless steel elements are directly mounted on the stripped wall

During rehabilitation work, old, unretentive pools were restored to a new condition which corresponds to the latest state of the art. The existing pool head (the area between the circumference and the upper edge clearance) is initially removed in order to obtain a level surface for the installation of the new pool elements. The stainless steel wall elements with the substructure are mounted on the original pool wall. With the untensioned lining, the existing satisfactorily straight wall is able to absorb the hydrostatic loads of the water pressure so that the lining is directly (untensioned) closefitting against the original pool wall (sectional drawing 1).

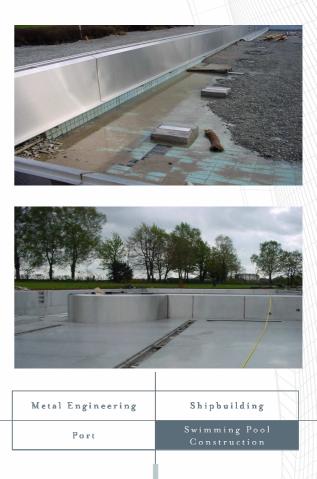
If an untensioned lining is not possible, a construction behind the stainless steel walls is able to absorb the water pressure of approx. 5 tonnes per square metres-. After the floor channels have been installed and stabilised with concrete, one fills the spaces with coarse gravel and fine aggregate material. The floor plates are then laid according to plan and welded so that they are waterproof. The pool is then subjected to steeping treatment and can then be filled with water.

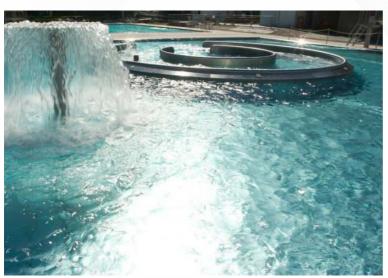
Rehabilitated experience pools with a flow channel, water mushroom and chute Water surface: 945 m² I Year of construction 2002

One of the rehabilitation tasks in Munich was the subdividing of a 50 metres competition pool into 2 separate functional areas - experience and swimming areas. The pool head of the existing reinforced concrete pool had to be stripped first so as to make space for the new wall elements with an overflow gutter.

The former pool form was subdivided into two individual pools by means of new reinforced concrete partitions. Prefabricated wall elements were installed in the pools. The existing walls supported the inserted metal pool. The pool floors were also in the form of a metallic skin, whereby the forces were transmitted to the substrate (fine aggregate material and coarse gravel).

Stainless steel wall elements as a self-supporting construction were installed to a water depth of approx. 2 metres. The experience pool was equipped with numerous new attractions: e.g. stainless steel chute, flow channel, water mushroom, floor geyser, water shoot, floor jets.

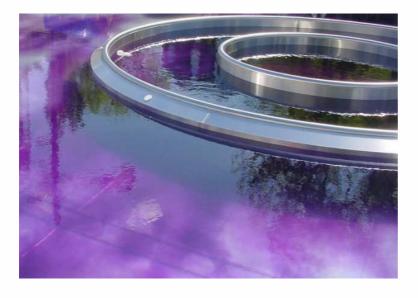
The dye test demonstrates the passing through of the pool

After the pool had been installed, the tightness of the complete construction was tested for a period of five days by it being filled with water. After the initial filling had taken place, proof was furnished of the functionability of the pool hydraulic system by means of a dye test.

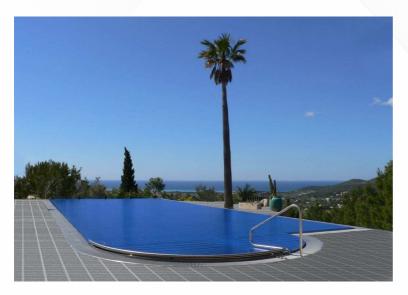
Rehabilitated pool with a lamella cover and glass face wall Water surface: 94.5 m² I Year of construction 2005

The former reinforced concrete pool head was initially uncovered. The complete prefabricated pool components were transported to the construction site on lbiza by truck and positioned at their place of installation by means of a crane. The complete walls were mounted on the cut-off former concrete walls within a few days.

After the walls had been positioned and the concrete layer had been applied, the floor of the pool was filled with fine aggregate material and coarse gravel before being compacted. The floor plates were then laid on this level bed has planned.

The outdated pool hydraulic system was replaced by floor channels for the streaming in of the water; a vertical passing through of the pool ensures an optimal water exchange and hygienic conditions.

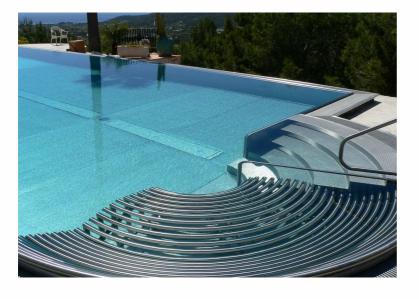
Whirlpool loungers and steps with handrail at the entrance

It was now possible to weld the floor plate for plate. The whirlpool loungers were then placed in a prefabricated foundation and connected.

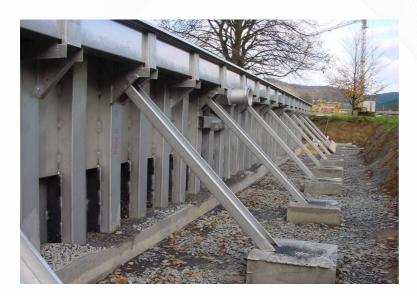
The rear support supports the stainless steel walls

A rear construction (bearers welded to the wall and anchored to the floor with a concrete layer) stabilise the self-supporting side wall. The overflow gutter and stainless steel elements are mounted to the pool head. After all of the fittings have been installed and the concrete layer applied, all of the spaces in the floor are filled out with a fine aggregate material and coarse gravel so as to provide the floor plates with a level surface. These are laid according to plan and welded so that they are waterproof.

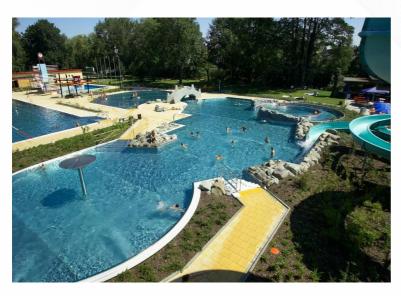
Swimmer, diving and experience area with a flow channel Water surface: 1,625 m² I Year of construction 2004

First of all, the former pools and their foundations had to be broken up and removed. A level surface was created so as to enable the supplied stainless steel walls and the corresponding fittings to be installed. More than 15 companies worked on the construction site at the same time. Today, a modern treatment system ensures that the pool water meets the latest legal requirements. The pumped off and treated water for the Aachbad comes from the River Aach close by. The more than 2 million litres of water are economically and ecologically heated up by use of a solar absorption system on the roof with more than 1200 square metres of pipelines. This makes it possible to achieve an average water temperature of approximately 23° Celsius and is therefore extremely economically viable for the future. The new competition pool which is of Olympic dimensions was constructed in a self-supporting design.

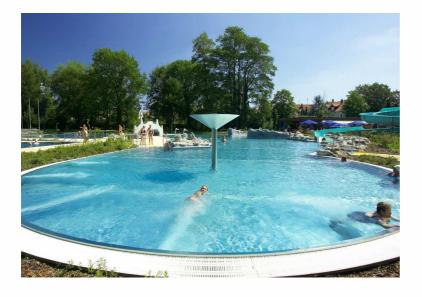
Water mushroom un the massage area and a giant chute with run-out pool

The experience area of 875 square metres is next to this pool. Here, attractiveness is guaranteed by a water mushroom (2.5 metres diameter), two gush showers, two water canons, one of which swivels, a massage area with floor bubble devices and a flow channel. Comfortable pool accesses with various water depths and a large chute which is almost 100 meters long ensure a comfortable bathing experience.
